# BECKWITH STREET REVITALIZATION

## CONSTRUCTION PROGRESS UPDATE NO.18

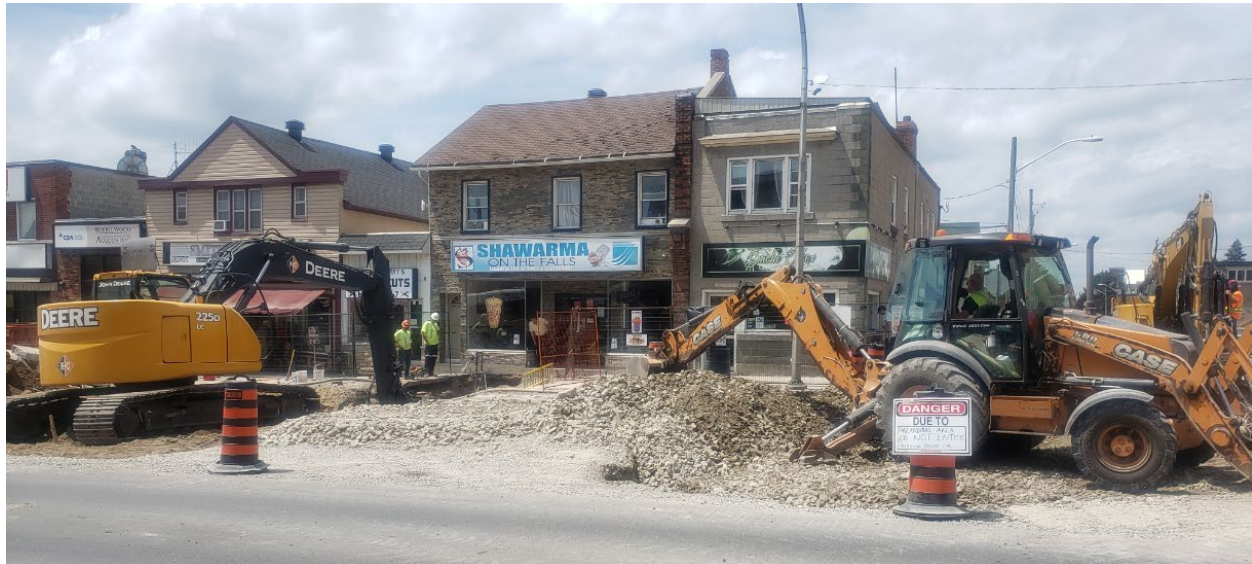
The watermain on Beckwith Street is nearly commissioned. The pressure test was successful, and the bacteriological sampling process has begun. While the final stage of the testing procedure is underway, two sewer crews continue down the west side of Beckwith Street installed water and sewer services to each property.

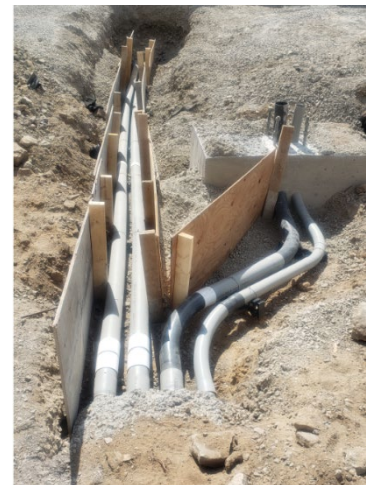
The road crew has also been busy and has completed the intersections of Main Street West, William Street West, and Russell Street West. They have also completed the removals of the existing concrete curbs and sidewalks in the surrounding areas. The electrical contractor has also mobilized to site and commenced the installation of the new underground infrastructure. The southeast corner of Main Street East is nearly complete, as well as the northeast corner of Chambers Street.

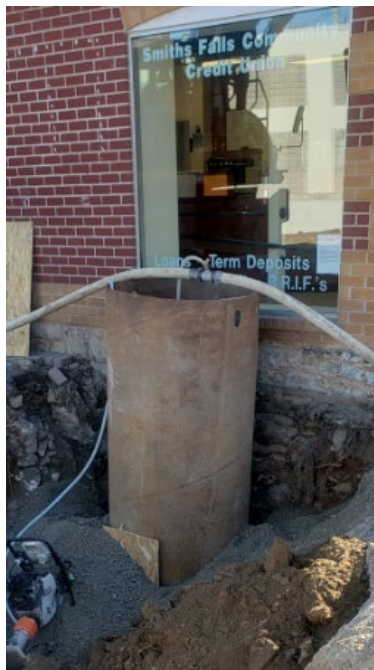
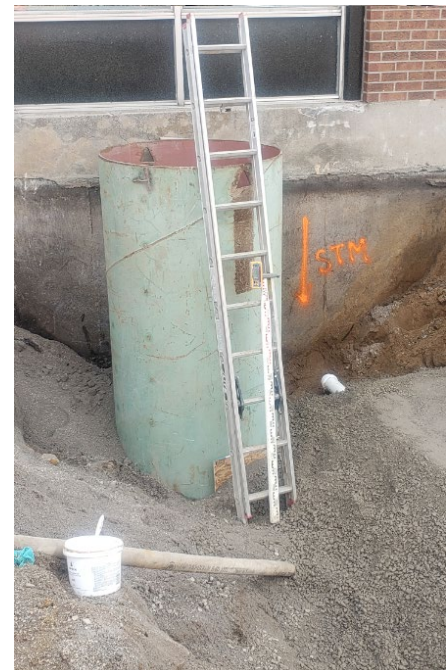
The large steel casings that are visible all along the East side of Beckwith Street are used during the installation of the new copper water services. They are used in situations when the new water service can not be directly connected to the existing properties service if the new watermain has not been completed and commissioned (the case on Beckwith Street).

They allow a Contractor to continue working on services, and to backfill the service trench while the work on the watermains continue.

Once the full watermain passes its commissioning process, the Contractor can return to the casings and a worker can enter the casing with a ladder to make the final connection to the new copper. After the connection is completed, the casing is removed and the area is backfilled and compacted. This saves a tremendous amount of time, as the service does not have to be carefully excavated a second time.
