# BECKWITH STREET REVITALIZATION

## CONSTRUCTION PROGRESS UPDATE NO.23 – THE FULL PICTURE

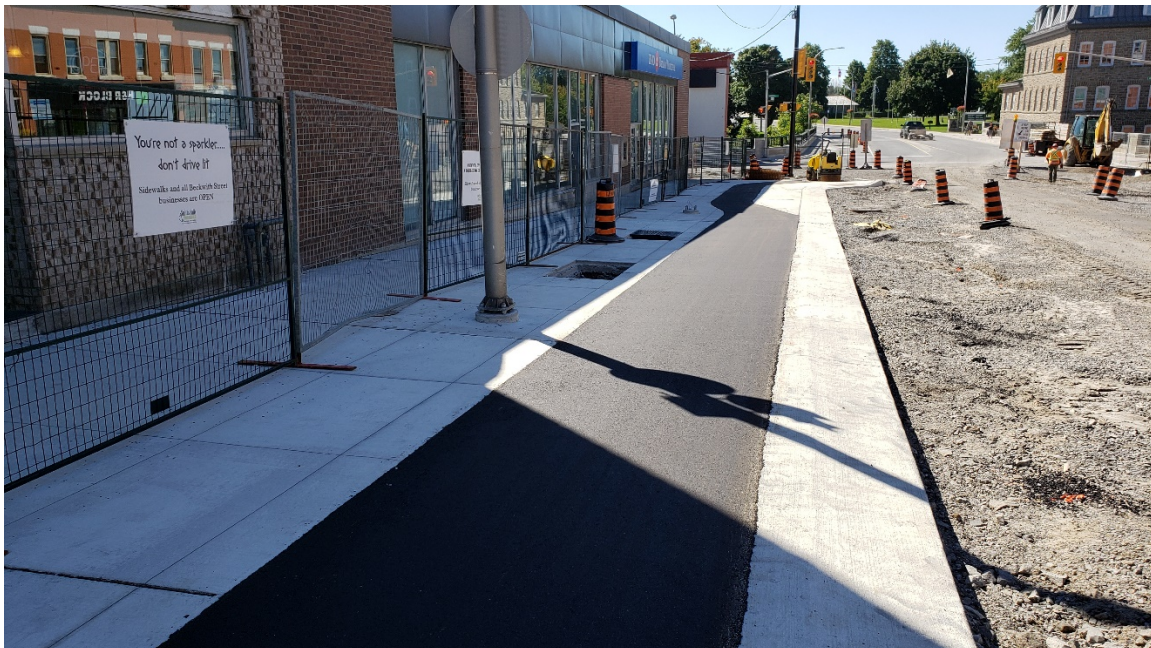
The installation of new concrete sidewalks are continuing to progress at a steady pace. To date approximately 75% of the sidewalks have been placed, and in many areas the Contractor has been able to place the asphalt for the new bicycle path as well. Once the one way cycle tracks are paved the picture of the new pedestrian/cycling zone is becoming very clear.

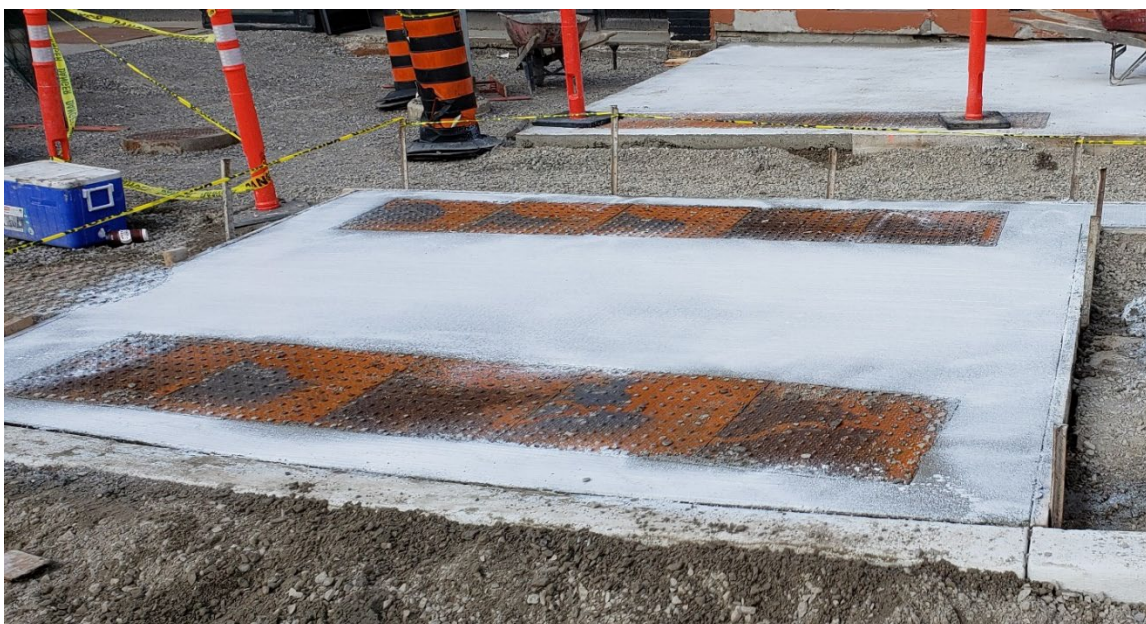
Did you know that the rectangular steel plates at the corners of intersections are called “Tactile Warning Surface Indicators (TWSI)”? The name of these devices may be long, but it provides plenty of information on the purpose.

The TWSI’s have raised bumps (tactile) on them and are made of steel so that the combination of difference in material from the surrounding smooth concrete (surface) provides those who are visually impaired with a notice (indicator) that they are about to cross through a more dangerous area (warning) that has vehicle or bicycle traffic.

Ontario’s construction industry started implementing the use of TWSI’s in lieu of the older style of sidewalk markings which featured grooved channels in the sidewalk that directed an individual to pedestrian crossings. Although the old style functioned to assist visually impaired, the additional grooves and channels created more difficulty for individuals using mobility assisted devices such as walkers, wheelchairs and scooters.
